Tips for Tankers

or Lessons Learned and Re-learned

by Colonel Christopher V. Cardine (Retired)

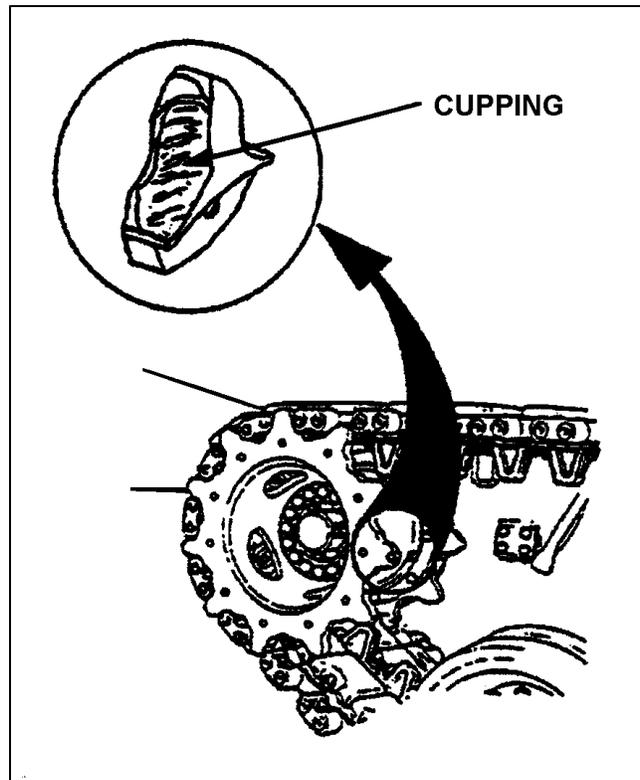
Fig. 1

Have you ever wandered through the motor pool on an inspection and found a tank that has strangely worn end connectors and sprockets that have cups in their teeth? (See Fig. 1) Is it bad track quality? Improperly hardened sprockets? A bent roadwheel arm? No, it's a crew that thought they followed the track adjusting

procedure, but really did not. The track is actually overtightened. This, despite the fact that the track adjusting link (TAL) has an automatic relief valve to prevent this. How do they do that, you ask? Simple.

If you go down to the motor pool to do maintenance and tell soldiers to adjust track tension, they will do the following: They get their grease guns and pump grease into the TAL until it comes out. Unfortunately, when they parked the tank the night before, they stepped on the brakes and then set the parking brake.

If you refer to the technical manual, it tells you before adjusting track to move the tank forward on a level surface and let it coast to a stop without applying the brakes. This is so the TAL will be the only thing pressing against the track while you add grease. When the appropriate tension is there, the grease will come out through a one-way relief valve. (Fig. 2)

My soldiers never do this, you say. Walk through your motor pool and watch! Also, see how many tanks have cupped sprockets. It is a great maintenance indicator.

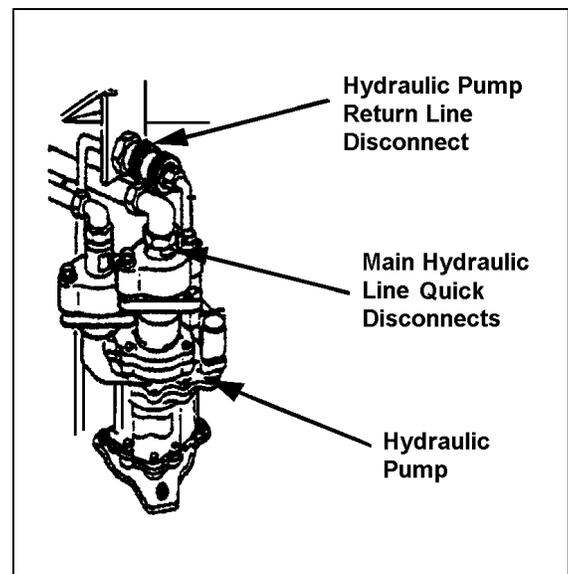
Fig. 3

When a pack is pulled and reinstalled, most mechanics do a good job of tightening the new style main hydraulic lines on the top of the pump. Where they make mistakes is when reconnecting the hydraulic pump case drain (return line) quick disconnect coupling. (See Fig.3) If it is not properly seated and positively locked, the oil flow is off. There is no oil leak because the quick disconnect is self-sealing when improperly installed or disconnected. Unfortunately, there is also no oil flow out of the pump during certain overflow conditions. This can generate sufficient pressure to cause the pump to burst, spraying hot oil in the engine compartment.

What's the cure? Training your mechanics, and a quality check by your maintenance supervisors of the quick disconnects after services. A leader who knows how to reach in and check for a properly seated QD does a lot to ensure that the soldiers do it also. Take your time to learn the feel on this one, as it is tricky.

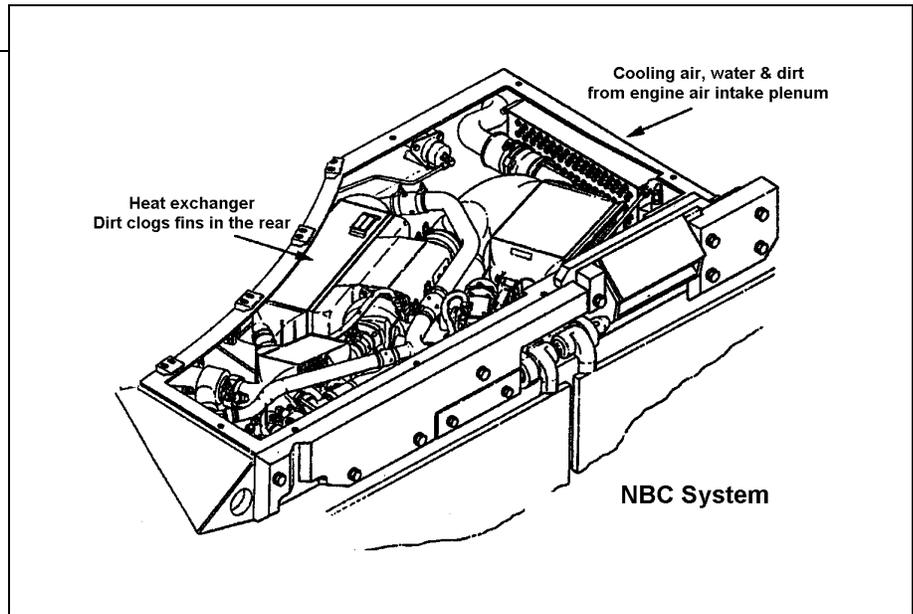
Fig. 4

crew compartment before it is bulk dumped and/or delivered to the individual crewman’s protective mask. Cooling air is also drawn into this area through a particle separator that shares the incoming raw air by the engine air filter intake. The main cause of problems is the neglect of the sponson area. (See Fig. 4)

The most difficult radiator face to check for dirt blockage is the heat exchanger because its inlet face is inboard, by the turret wall. In normal operation, the dirt/dust passes through the heat exchangers, ACM, and pre-cooler and is dumped overboard. When also mixed with water, it tends to stick to the face of the heat exchanger. During operation, chunks of mud may be passed through

the heat exchanger and into the ACM. This debris can cause high speed fan instability. This instability can cause an ACM stall/seizure resulting in high temperature bleed air reaching the M48 charcoal impregnated paper filters in the crew compartment. A spontaneous fire can result if the crew does not shut the NBC system down when an overtemp warning light illuminates. Letting the system “cool down” and then restarting it does not solve the problem; it only makes the probability of a fire greater! An MWO is being worked to try to limit mud ingestion in this area, but for now it must be inspected and cleaned during semi-annual services.

During semiannual services, the sponson area must be thoroughly cleaned and inspected. All hoses and clamps must be perfect. There must be no water or dirt in this area. There are three radiator-like devices in the sponson (heat exchanger, condenser, and pre-cooler) that must not be clogged with dirt. Water and dirt enter this area when mud builds up in the engine air intake area and the tank is parked facing downhill. Although the system was designed to operate in adverse conditions, when it is not operating, water can accumulate in the sponson area. A mixture of water and fine dust can enter the heat exchangers and the air cycle machine. If they are allowed to remain submerged in this corrosive, cement-like mixture, the ACM can corrode over time and the exchangers can become blocked. This is why it is essential that a tarp be placed over this area and tanks parked with the rear end facing downhill in wet climates.
