# Tank Gunnery Lessons Learned II

*50 Years of Forging the Thunderbolt*

WEAPONS DEPARTMENT • FORT KNOX, KY  
NOVEMBER 1990

SUBJECT: Tank Gunnery Lessons Learned II

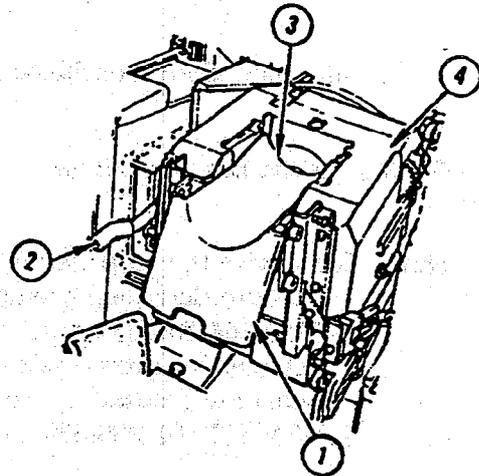
- e. Install stub base deflector (1) (see TM 9-2350-264-10-3, page 3-183/TM 9-2350-264-10-2 (September 1990), page 3-193).
- f. Put SAFE/ARMED lever (2) down to SAFE position. Stub base deflector (1) should drop quickly and smoothly to bottom of breechblock (3).

- g. Manually close breechblock (3). Breechblock (3) and stub base (1) should rise smoothly to top of breech ring (4).

**Note.** A correctly aligned stub base deflector is essential to ensure the 120-mm gun system functions properly. Deflectors that are out of alignment cause rounds to stick during loading and the stub base to jam during recoil. In addition to causing the loss of engagement time in combat and training time on ranges, deflectors out of alignment create potentially hazardous safety problems. To avoid these problems, the following procedure should be applied before firing, after firing, and as needed during firing.

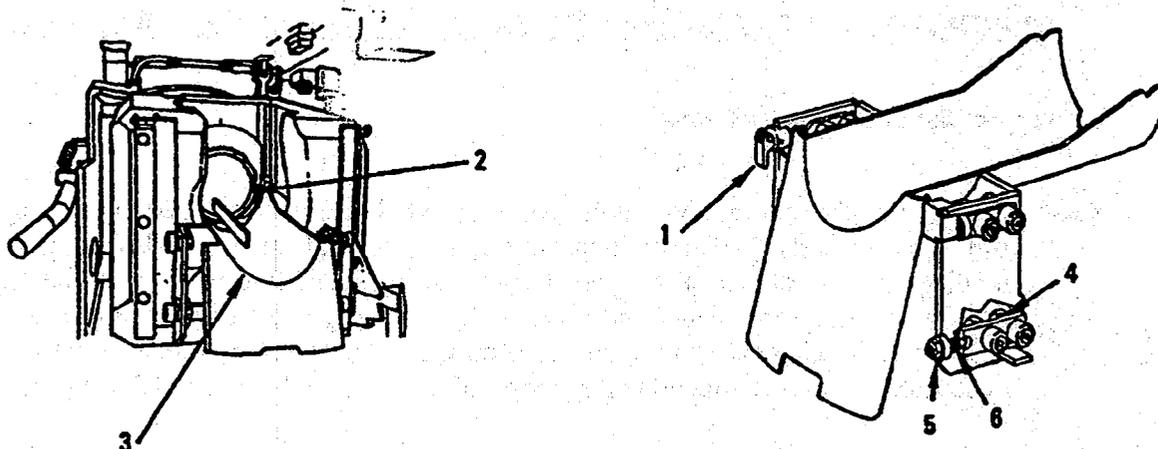
### 2. Adjust the Stub Base Deflector.

**Note.** Position lever (1) must point down.

- a. Set rule part way in gun tube (2) and part way over bottom of tray (3). If bottom of tray (3) is flush with bottom edge of rule, and flush with gun tube (2), go to step (c).
- b. Adjust tray (3).
  - (1) Remove tray (TM 9-2350-264-10).
  - (2) Loosen four bottom cam follower nuts (4).
  - (3) Install tray (TM 9-2350-264-10).
  - (4) Loosen two nuts (5). Turn two screws (6) until tray (3) is flush with gun tube (2). Tighten nuts (4) and (5).
  - (5) Remove tray (TM 9-2350-264-10).
  - (6) Tighten nuts (4). Install tray (TM 9-2350-264-10).
- c. Manually close breechblock (TM 9-2350-264-10).

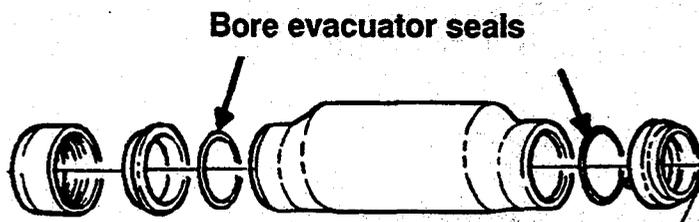
**Note.** To service the bore evacuator on the 120-mm gun tube of the M1A1 tank, follow the procedure described beginning on page 3-180, TM 9-2350-264-10-3/page 3-185, TM 9-2350-264-10-2 (September 1990). Steps E and G require the crewman to clean and check packing (bore evacuator seals). When a seal must be replaced, the proper type of seal must be used. The only seal that will allow the gun system to function properly is NSN 5330-01-280-6787, PN MS9021-371, regardless of color.

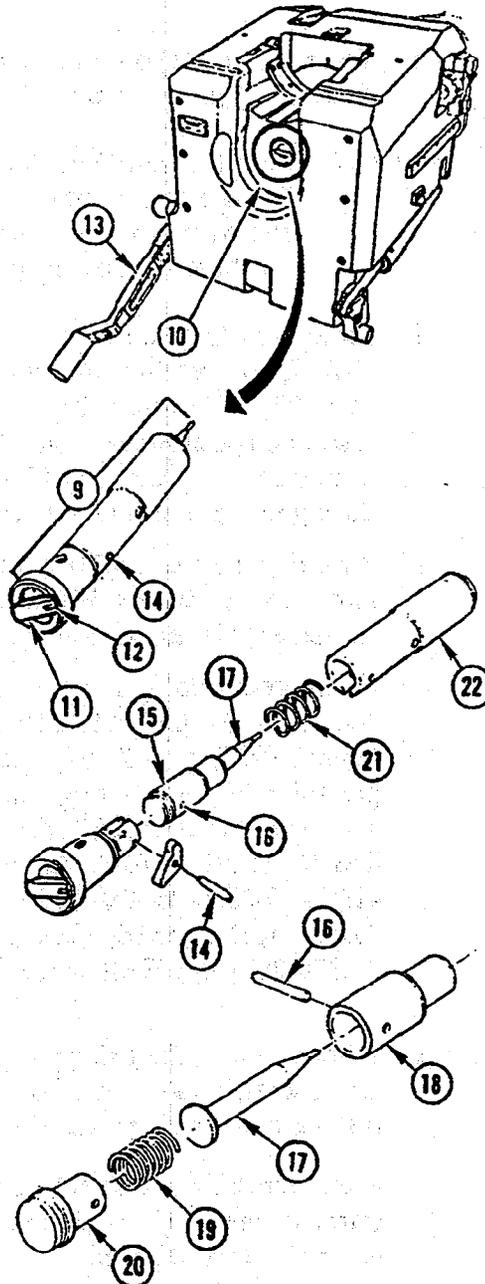
- f. Disassemble firing pin assembly (15) by removing straight pin (16) using drive pin and hammer.
- g. Check all parts for damage. If any part is damaged, notify organizational maintenance.

- h. Wipe probe (17) and all other parts with a clean dry rag (see TM 9-2350-264-10-3, Ap-

- i. Insert probe (17) into guide (18) and place spring (19) behind probe (17). Push cap (20) into guide (18) and insert straight pin (16) into guide (18) to hold assembly together.

**CAUTION.** Spring (21) and firing pin assembly (15) must be placed in housing (22) as shown. Failure to assemble firing mechanism assembly (9) as shown will cause damage to firing mechanism assembly (9).

**Note.** Main gun misfires are often the result of failing to make proper electrical contact. Two of the most common causes are dirty firing pins and contact probes. Crews can avoid this problem by thoroughly cleaning the breechblock and paying close attention to prepare-to-fire checks, including the caution to keep the firing pin clean and dry (see TM 9-2350-264-10-1, page 2-82/TM 9-2350-264-10-1 (September 1990), page 2-90).

**CAUTION.** Cam (23) must be assembled as shown. Failure to assemble the cam (23) as shown may result in damage to firing mechanism assembly (9).

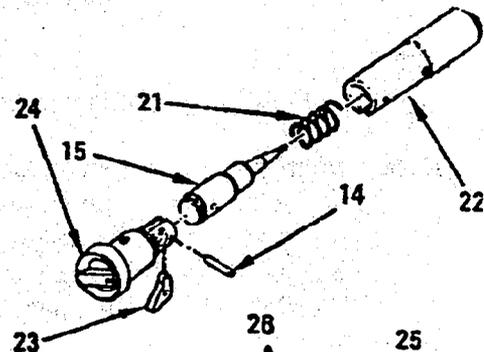
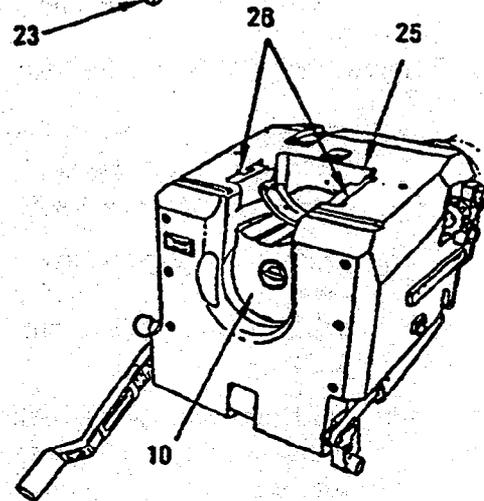
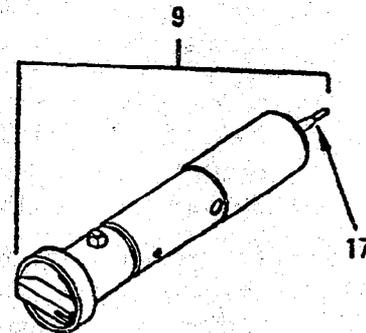
**Note.** When cleaning the firing pin and firing pin well, the crewman should use the standard green scratch pad issued from the unit supply. This scratch pad will easily remove any rust, carbon, or other dirt without removing the firing pin assembly protective coating.

After punching and swabbing the 120-mm gun tube dry, inspect the breech face and extractor area and dry all cleaner, lubricant, preservative (CLP) to prevent the firing pin from becoming wet.

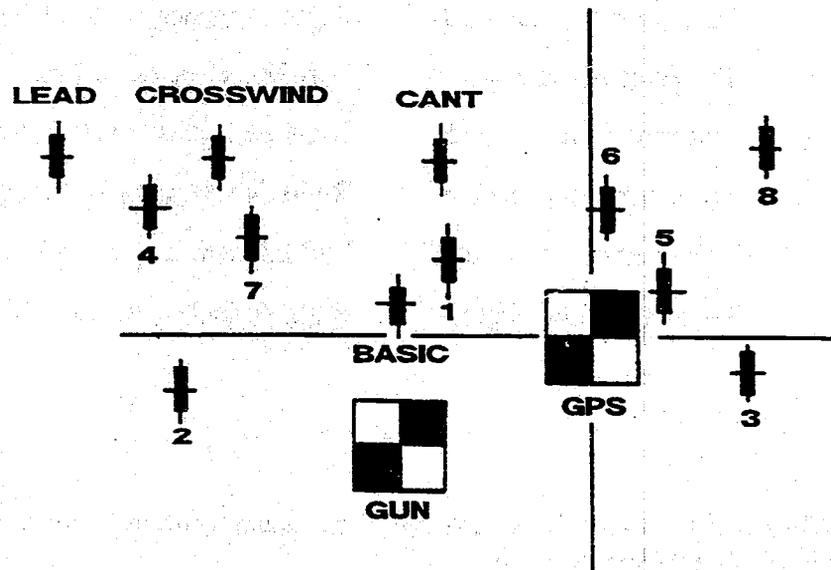
### M1/M1A1 Combined Solution Board

Previously, units needed two solution boards to complete Armament Accuracy Checks (AAC) 4 and 5. Reports from units in the field indicate that combining the solution boards for Checks 4 and 5 simplifies the procedures. Combining the solution boards also reduces the space needed to transport the boards for field use.

Minimum solution board dimensions are 96 inches wide by 60 inches high.

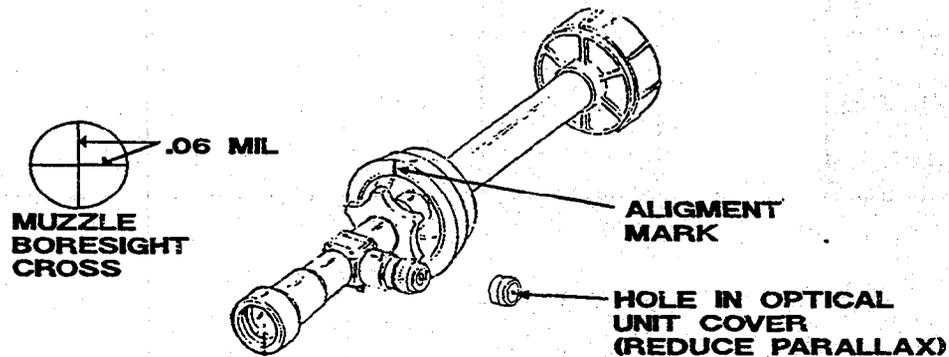
Other modifications or tighter tolerance changes have been made to the draw bar, optical head, reticle mount, objective lens and prism housing to increase accuracy.

Units who still have M26A1/M27A1 MBDs with a serial number under 9000 can turn these devices in through the supply system to receive an upgraded M26A1/M27A1 MBD.
